Case Study: River Monnow (HNL1 15m 66c) Monitoring railway for washout

Monitoring flood conditions of the River Monnow supports safe operation of the railway during extreme weather events.

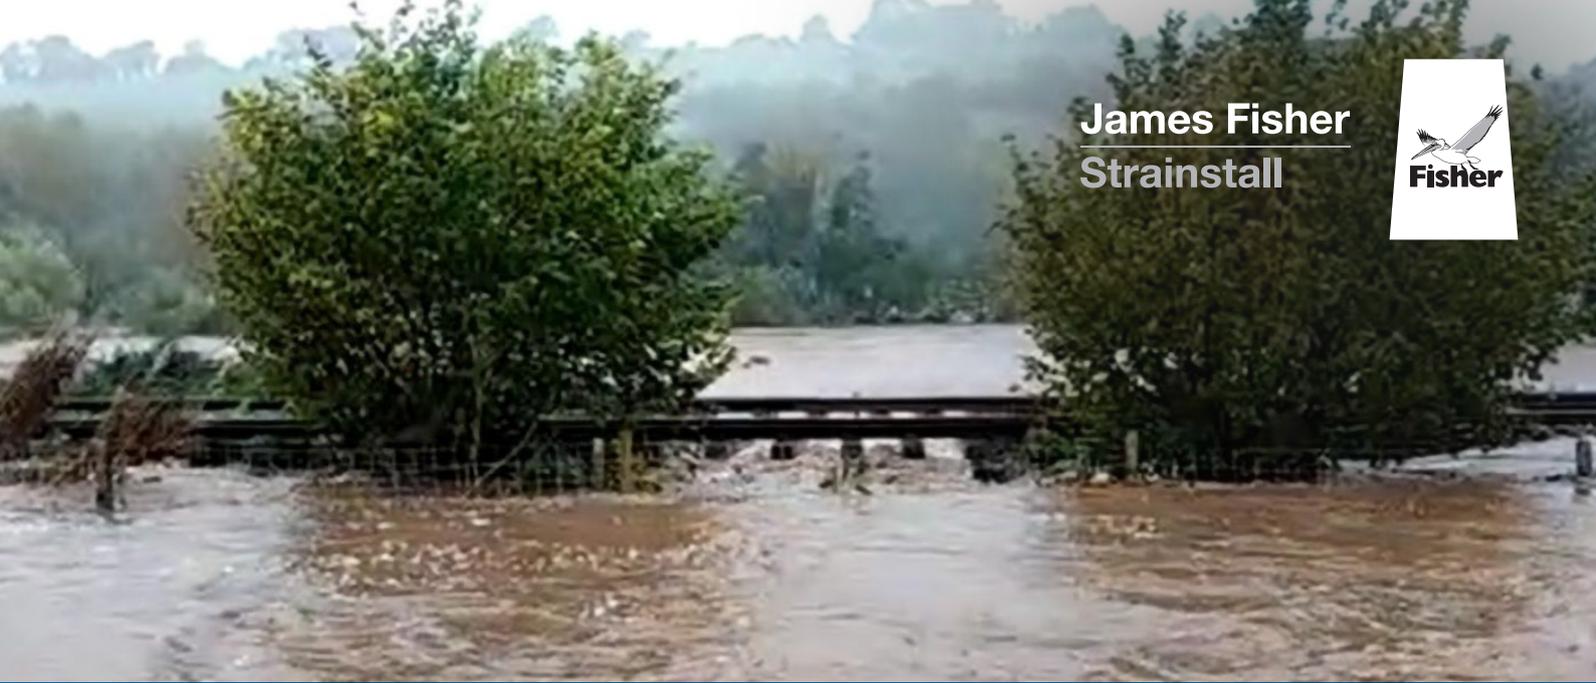
The Hereford and Newport line suffered under extreme weather in November 2019. Water levels in the river Monnow rose by more than 2 metres and overtopped onto adjacent fields. The flow of water and associated hydrostatic pressure broke through the track formation, washing out large sections of ballast and leaving the track literally suspended in mid-air. Neighbouring landowners called Network Rail to advise of the damage to track and they promptly closed the line to prevent risk to life.

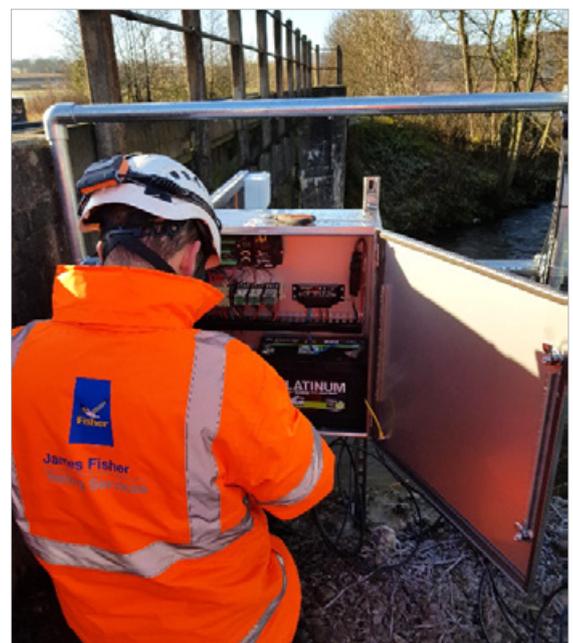
The challenge of installing a flood warning system in a remote location required careful consideration. Power is supplied to the systems by a 150W solar panel ensuring that they remain operative without mains supplies or the need to regularly change batteries. The systems had to be programmed to economise on power consumption, switching equipment between readings.

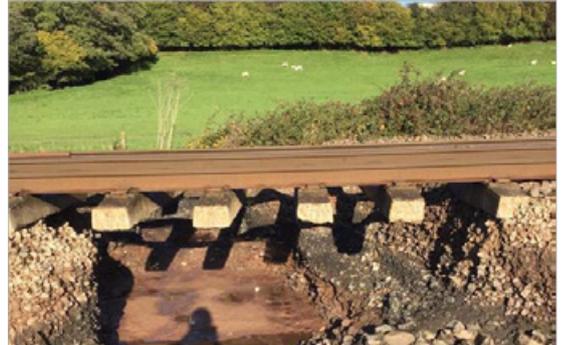
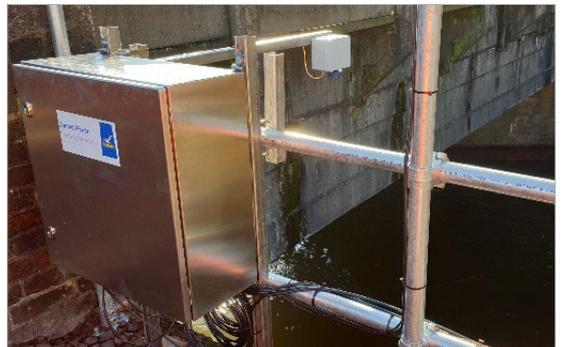
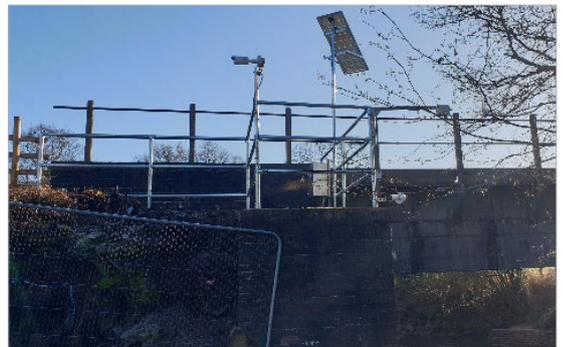
- River levels monitored, providing status with traffic light warning system (Red-Amber-Green)
- Analysis of rates of change drives warning system to inform NR when rivers are likely to overtop
- Automated alerts transmitted by email/SMS
- Trackside cameras situated on observe flow conditions in relation to the embankment height and condition of track.

“ The trackside cameras and river level sensor system at the River Monnow plays a key role in our adverse and extreme weather management process. The JFTS [rebranded JF Strainstall] system enables us to make crucial safety decisions remotely based on accurate live information reducing risk to staff by removing the need for boots on the ground. ”
